UNDERWATER BRIDGE INSPECTION REPORT

STRUCTURE NO. 69580
CSAH NO. 31
OVER THE
ST. LOUIS RIVER
DISTRICT 1 - ST. LOUIS COUNTY

PREPARED FOR THE
MINNESOTA DEPARTMENT OF TRANSPORTATION
BY
COLLINS ENGINEERS, INC.
JOB NO. 5221 (CEI 1)

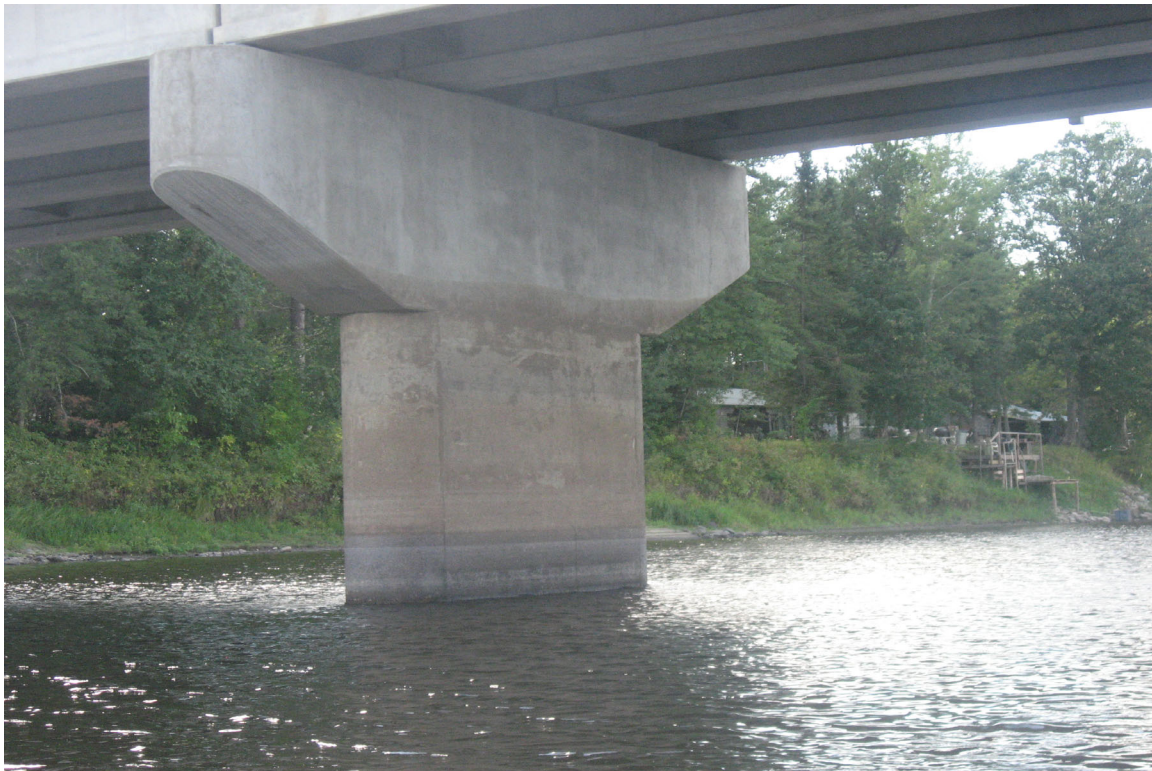
- (A) The concrete at both piers exhibited light scaling with 1/8 inch typical penetration and 1/4 inch maximum in a band around the pier extending from the channel bottom to 3 or 4 feet above the waterline.

Photograph 2. View of Pier 1, Looking Southwest.

- (A) Reinspect the submerged substructure units at the normal maximum recommended (NBIS) interval of five (5) years.

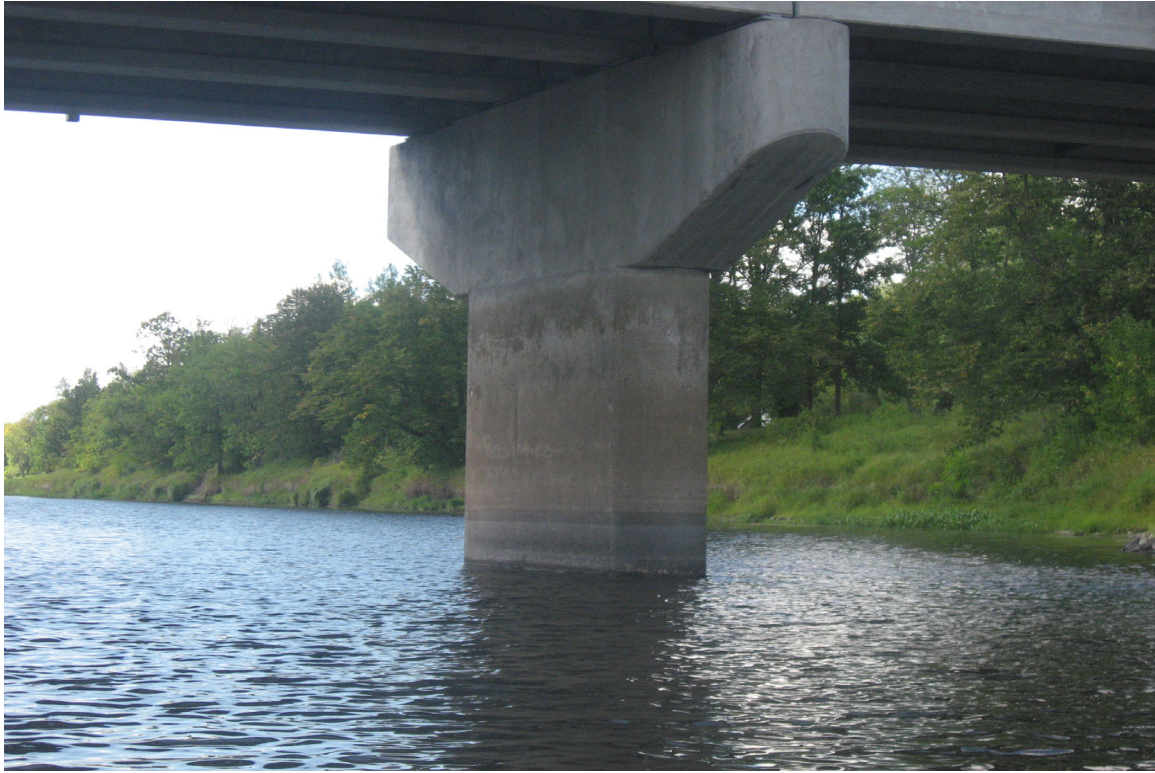
Photograph 3. View of Pier 2, Looking Northwest.

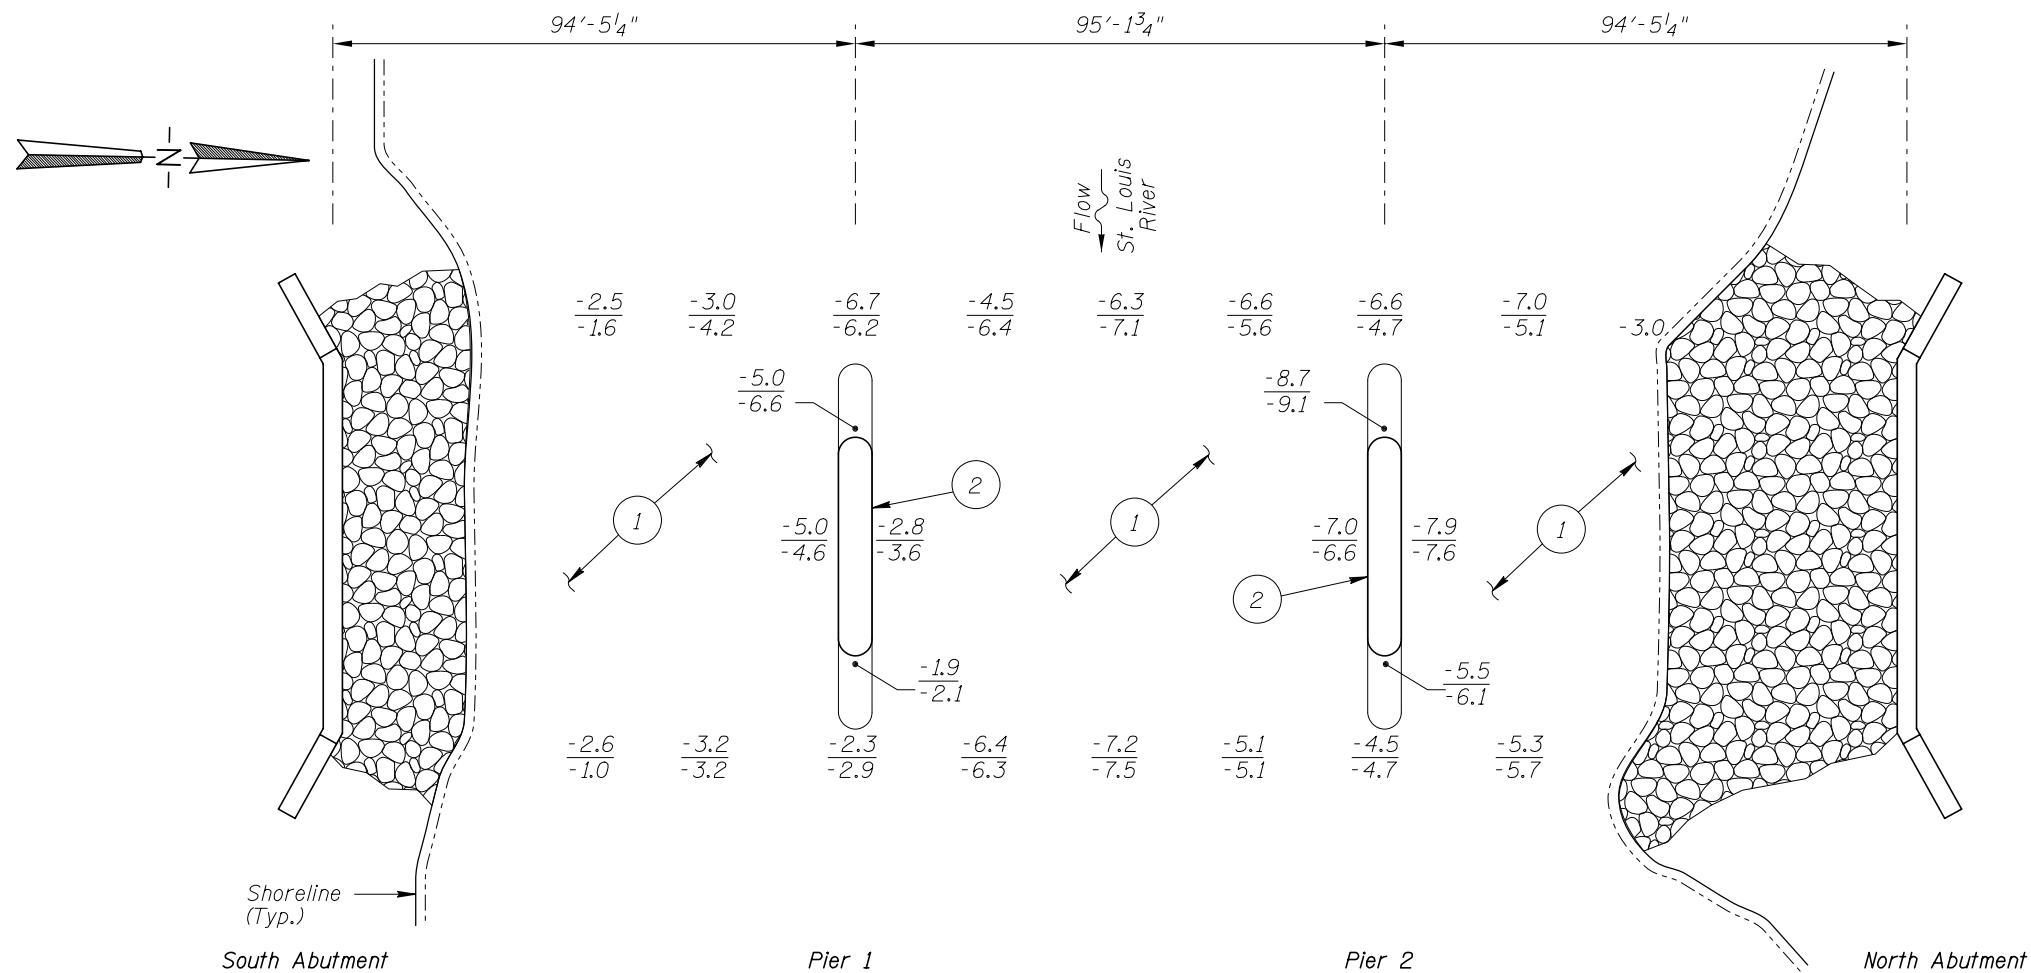
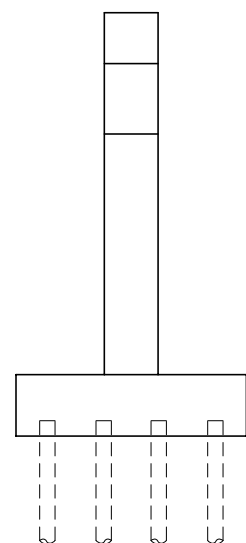
INSPECTION AND SOUNDING PLAN

- The channel bottom material consisted of 1-foot-diameter and smaller riprap and cobbles with no probe rod penetration.
- The concrete at both piers exhibited light scaling from 3 to 4 feet above the waterline to the channel bottom with a typical penetration of 1/8 inch and maximum penetration of 1/4 inch.
